# ODI RESUME

Investigation: EA 06-002  
 Prompted By: PE05-054  
 Date Opened: 01/24/2006      Date Closed: 02/05/2007  
 Principal Investigator: Derek Rinehardt  
 Subject: Rear coil spring fracture

Manufacturer: Ford Motor Company  
 Products: 2000 & 2001 Ford Taurus / Mercury Sable  
 Population: 411779

**ENGINEERING ANALYSIS CLOSING REPORT**

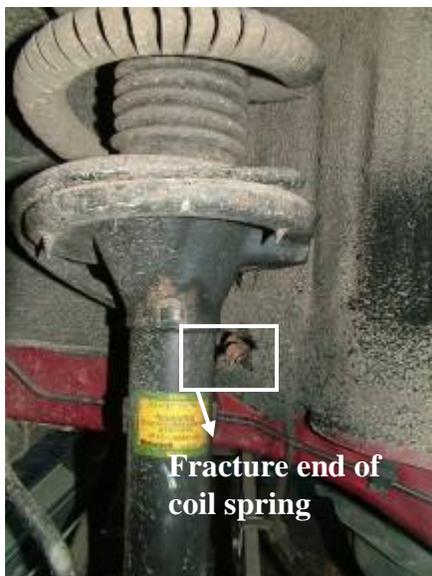
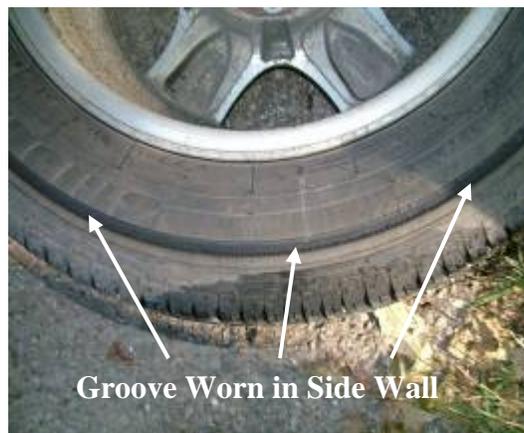
**ALLEGED DEFECT:** The alleged defect is a fracture of the rear suspension coil springs causing damage to the adjacent tire (see figures 1 and 2), resulting in a sudden air loss or loss of vehicle control.

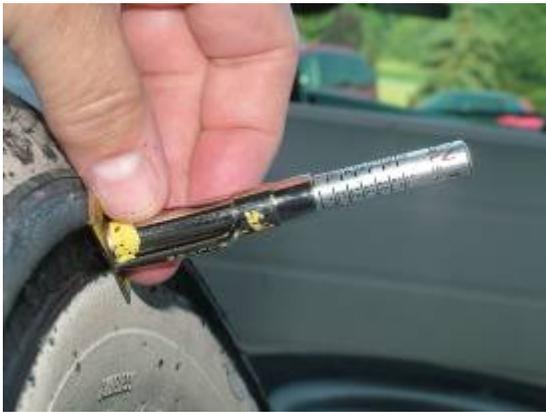
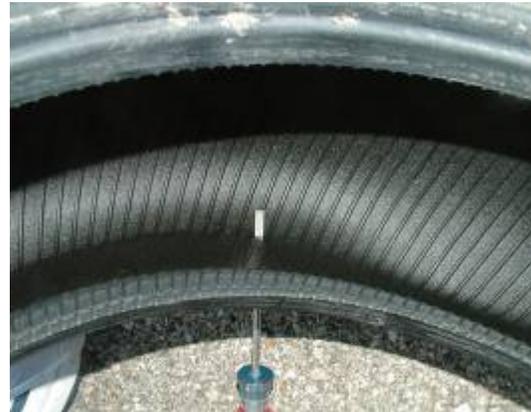
spring rubbing against the inner sidewall of the tire from the starting point. The vehicle was driven 3.8 miles before there was air loss in the tire. During the drive evaluation, the driver reported no loss of vehicle control, however the driver indicated the smell of rubber was apparent. After installing the space-saver spare tire, there was no contact between the broken spring and the tire. Examining the full size tire after the testing was completed, the tire experienced similar damage as found in data submitted by Ford and information submitted by consumers to ODI. On the sidewall the depth of the groove caused by the fractured coil spring was approximately 7/32", however the hole through the inner wall was small (see Figures 3 and 4).

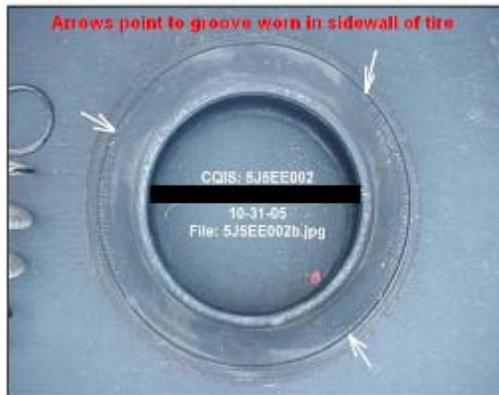
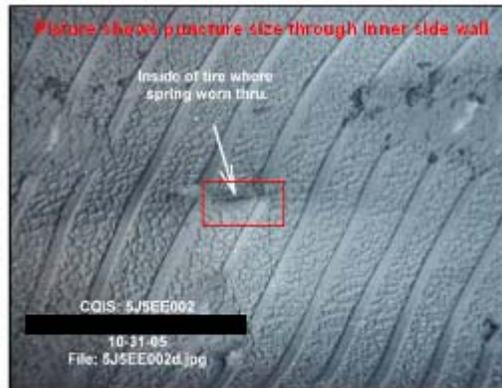
Ford contends that the majority of the responsive reports allege that a rear coil spring fracture did not result in tire contact. Ford also contends that when there is air loss due to contact from a fractured rear coil spring, the most likely event is for the coil spring to rub against the side wall for a period of time until the sidewall is eventually penetrated and a slow loss of air occurs (see Figures 5 and 6).
