# ODI RESUME

Investigation: EA 06-002  
 Prompted By: PE05-054  
 Date Opened: 01/24/2006      Date Closed: 02/05/2007  
 Principal Investigator: Derek Rinehardt  
 Subject: Rear coil spring fracture

Manufacturer: Ford Motor Company  
 Products: 2000 & 2001 Ford Taurus / Mercury Sable  
 Population: 411779

**ENGINEERING ANALYSIS CLOSING REPORT**

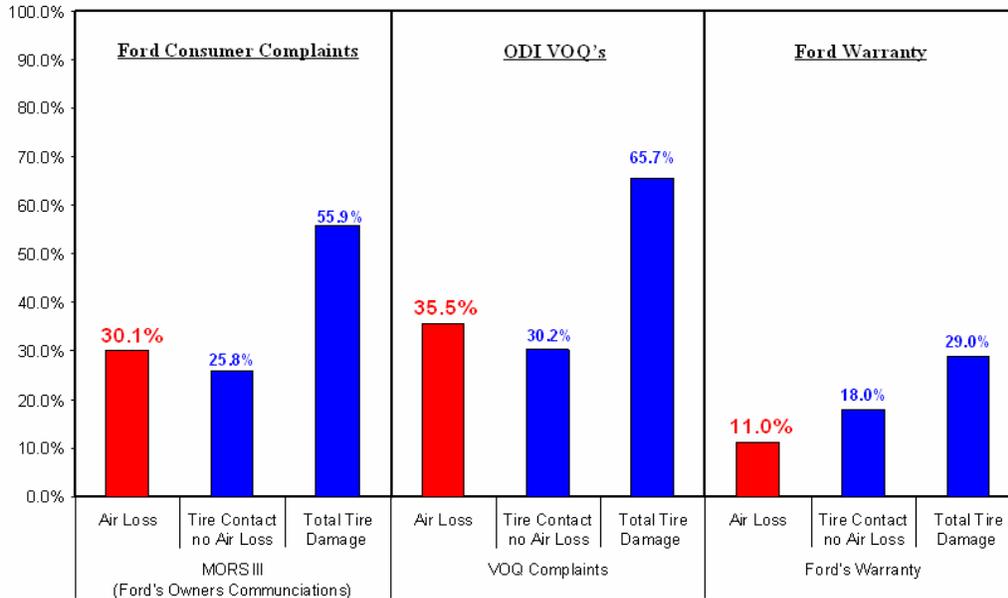
Chart 1

As part of PE05-054, an Information Request (IR) letter was sent to Ford Motor Company on 17-Oct-2005 and a response was received on 22-Nov-2005. At the end of PE05-054, analysis of Vehicle Owner Questionnaires (VOQ) complaint data and Ford Complaint and Warranty data showed that a significant percentage (see Chart 1) of consumers alleging rear coil spring fractures also alleged that the adjacent tire was punctured, causing air loss. To further assess if a safety related defect trend existed in the subject vehicles, ODI opened EA06-002.

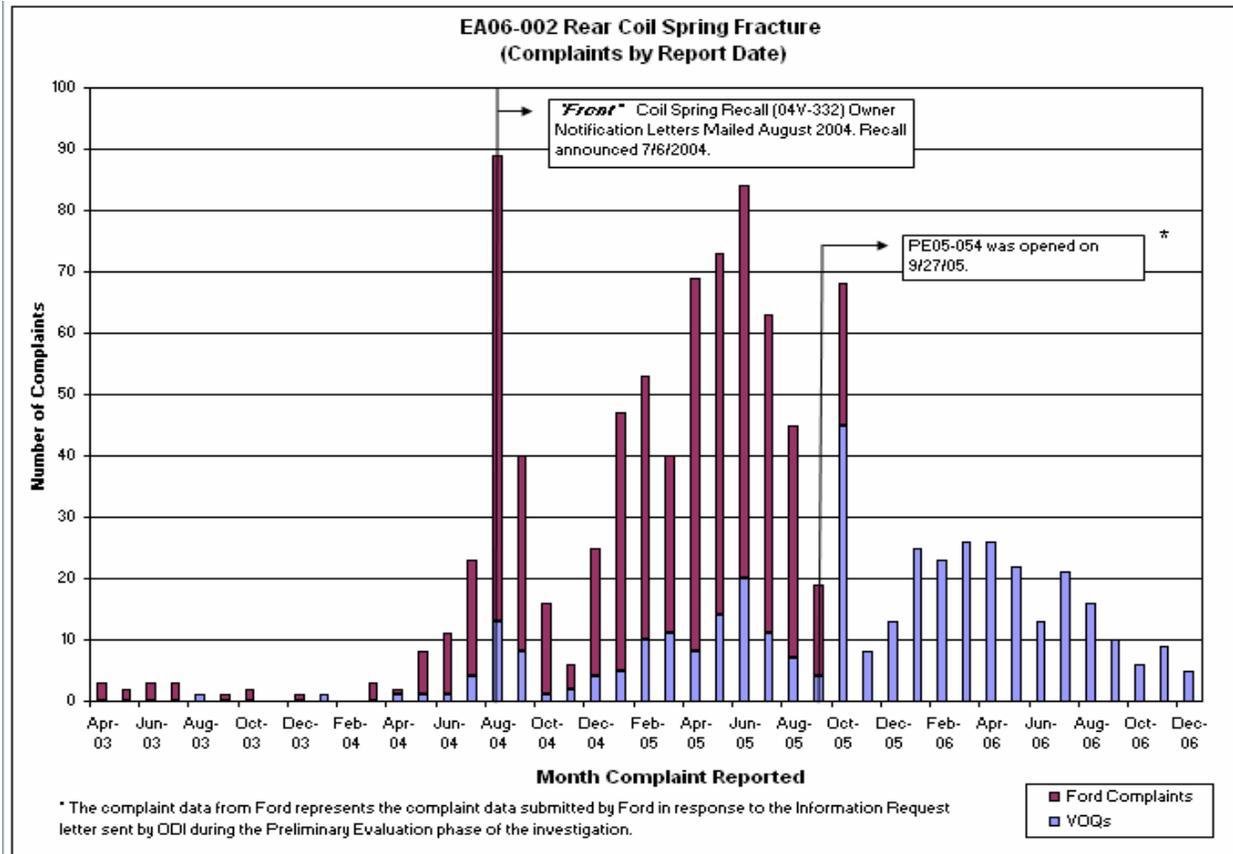
Chart 2

Ford contends that the recent increase in complaints related to alleged rear coil spring fracture is primarily due to the announcement of field service action<sup>1</sup> in 2004 regarding the front coil springs on the subject vehicles (see Chart 2). Ford believes that consumers whose vehicles have required rear coil spring replacement are contacting Ford to inquire about opportunities for financial assistance or to inquire if their vehicles are covered by any field service actions, since they are aware of the action being taken on the front coil springs. Ford contends that it has not received any reports of crashes, fatalities or injuries related to the alleged defect in the subject vehicles.

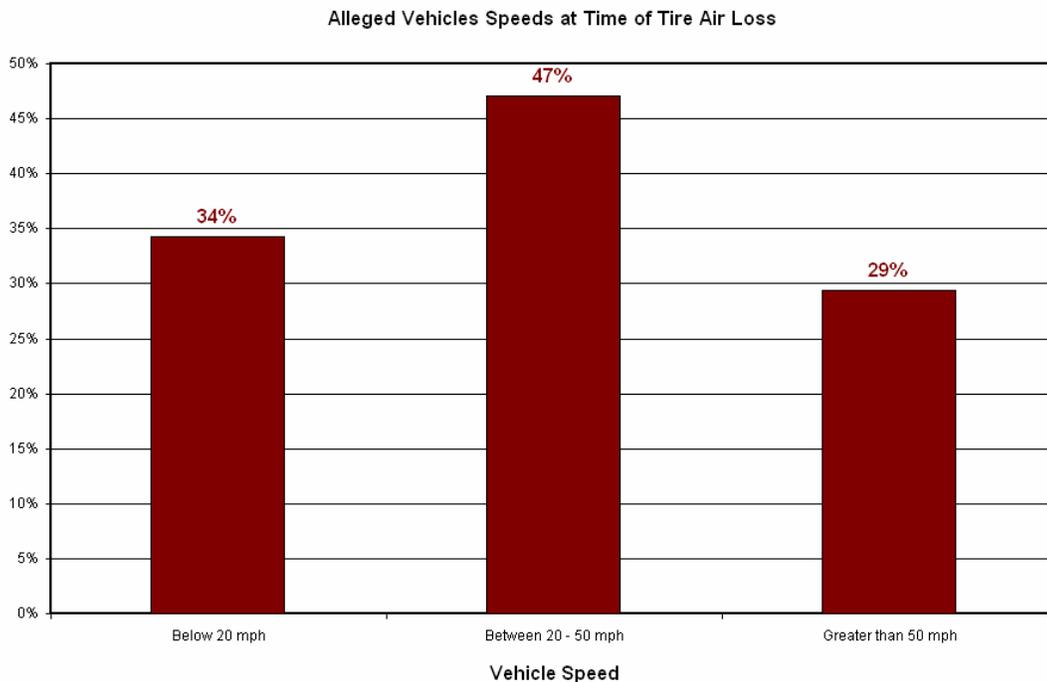
**Chart 3**

Of consumers experiencing the alleged defect and where there was air loss, approximately 29% alleged experiencing air loss while driving over 50 mph (see chart 3). None of these consumers alleged a crash or loss of vehicle control associated with the alleged defect. Likewise, consumers traveling at speeds less than 50mph have not alleged a crash or loss of control with the exception of the aforementioned consumers.

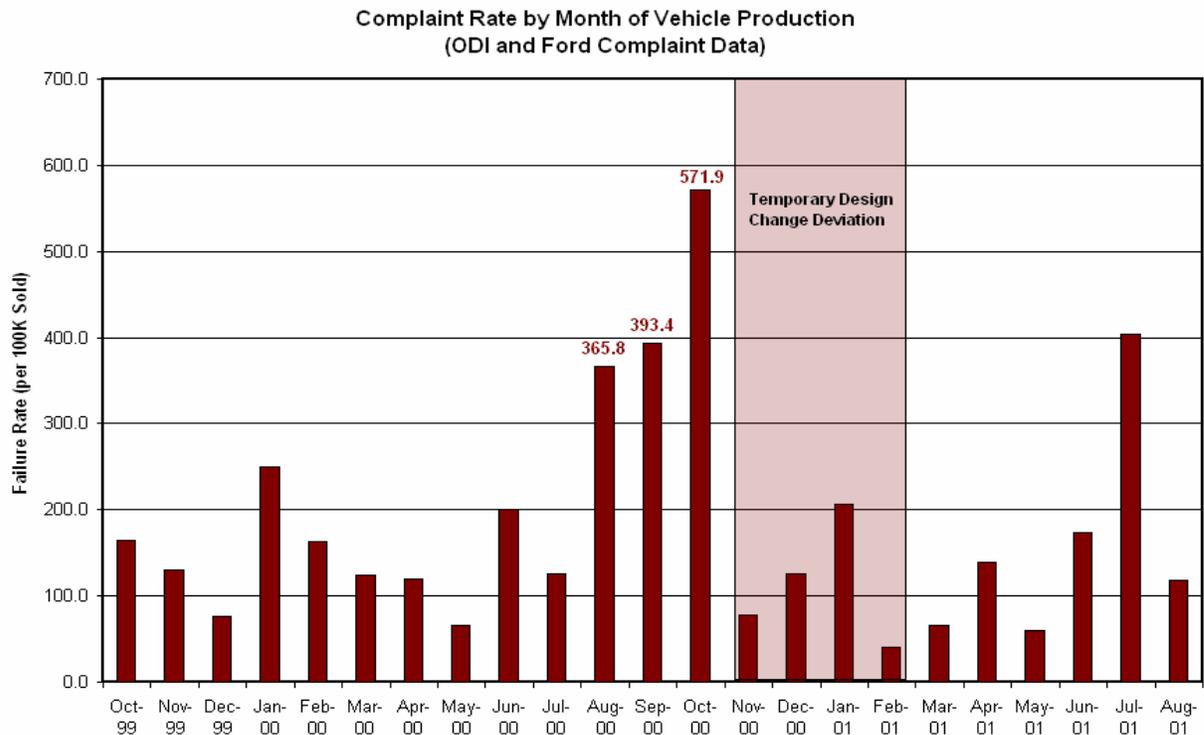
**Chart 3**

Ford implemented a temporary design deviation in the rear coil springs from 11/13/00 through 02/13/01 as noted previously in this report. Chart 3 below shows the rear coil spring failure rate by month of production based on consumer complaints. Although there is a drop in failure rate from October 2000 to November of 2000, the complaint rate in November of 2000 is similar to prior months of production in 1999 and early 2000. Also, when the released design change was put back into production, the failure rates remained consistent. Based on failure rate data, ODI could not draw a conclusion that the temporary design change was related to the alleged defect.

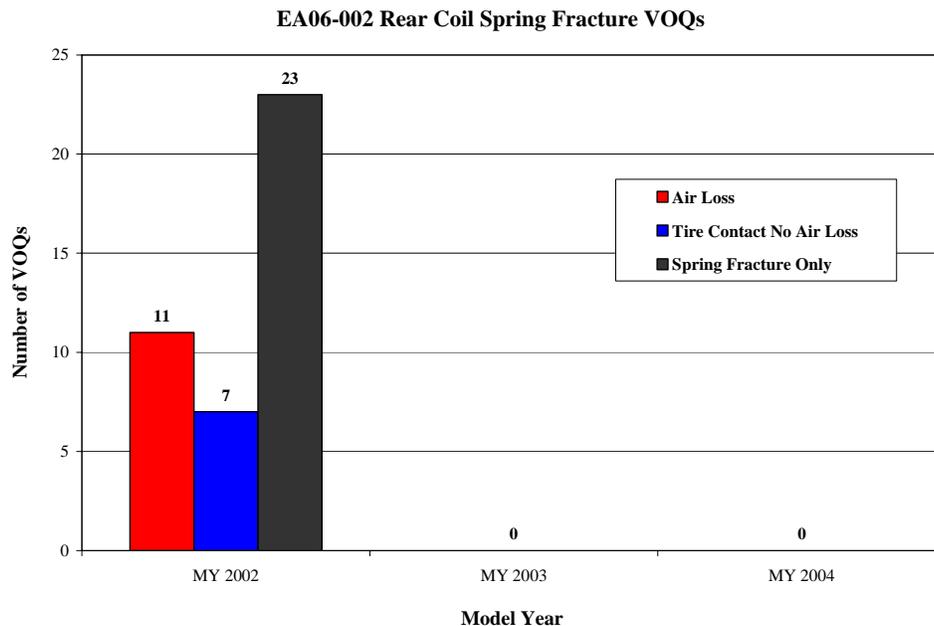
**Chart 4**

The scope of EA06-002 encompassed MY 2000 and 2001 based on known complaint information at the time of opening. ODI also did a review of complaints of model years beyond the scope of the investigation (MY 2002, 2003 and 2004). Chart 4 below summarizes the data. The review of the complaints did not reveal any allegations of crashes, injuries, fatalities or loss of vehicle control.
